New York State Department of Transportation

Yellow Flag NB2228W010

Flag Date: March 21, 2022

BIN: 1065318

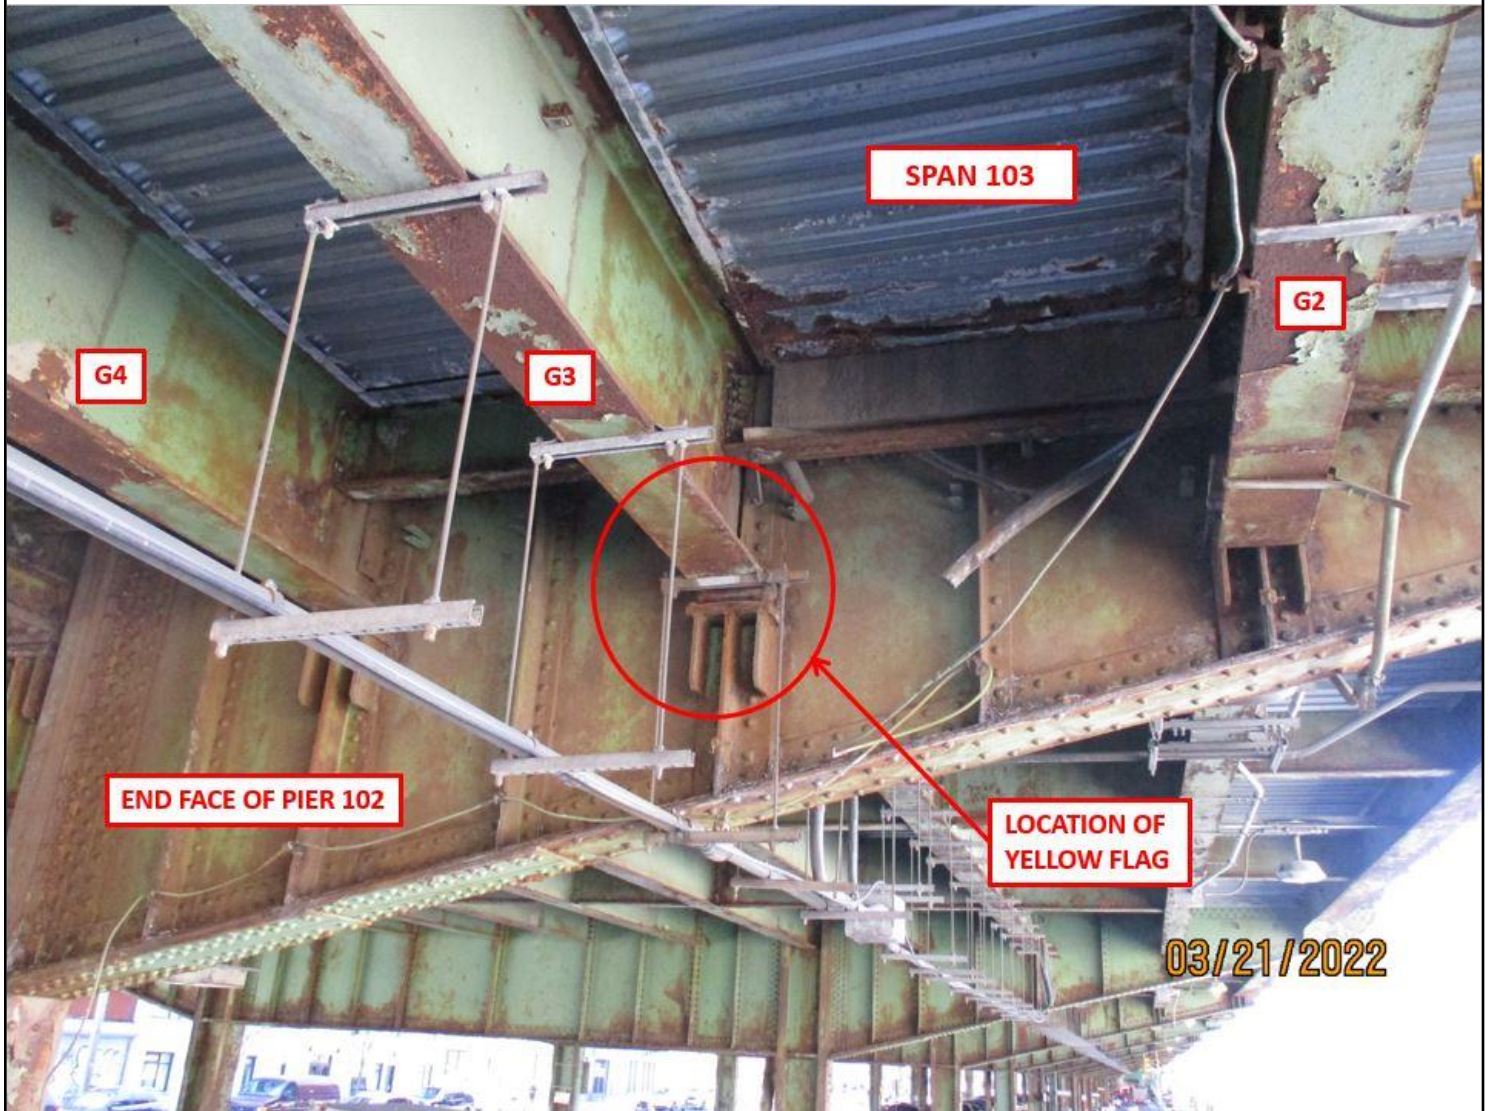
Photo Number: 1

Attachment Description: General view of the flagged condition at Girder G3 in Span 103 at Pier 102. Looking Begin.

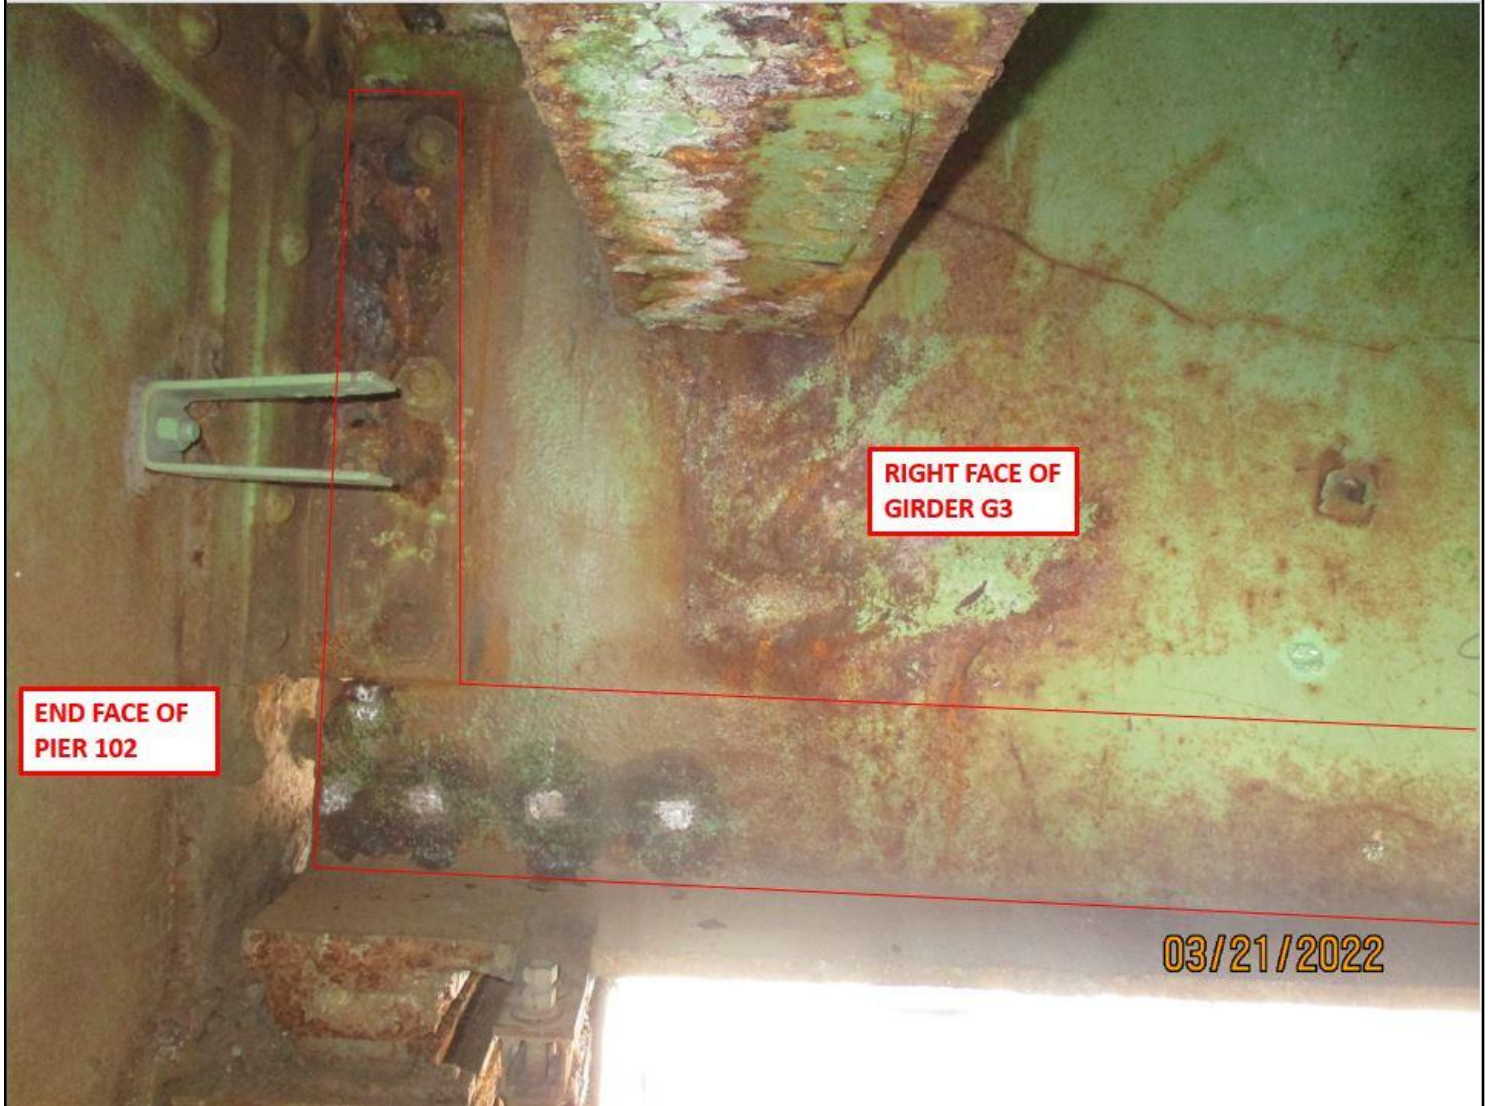
Photo Number: 2

Attachment Description: The right face of Girder G3 in Span 103 at Pier 102. The end of the girder exhibits severe section loss at the lower web above the bottom flange at the bearing area as well as in the web height behind the guide angle with a 15" x 2" corrosion hole at the end of the girder web. Looking Left.

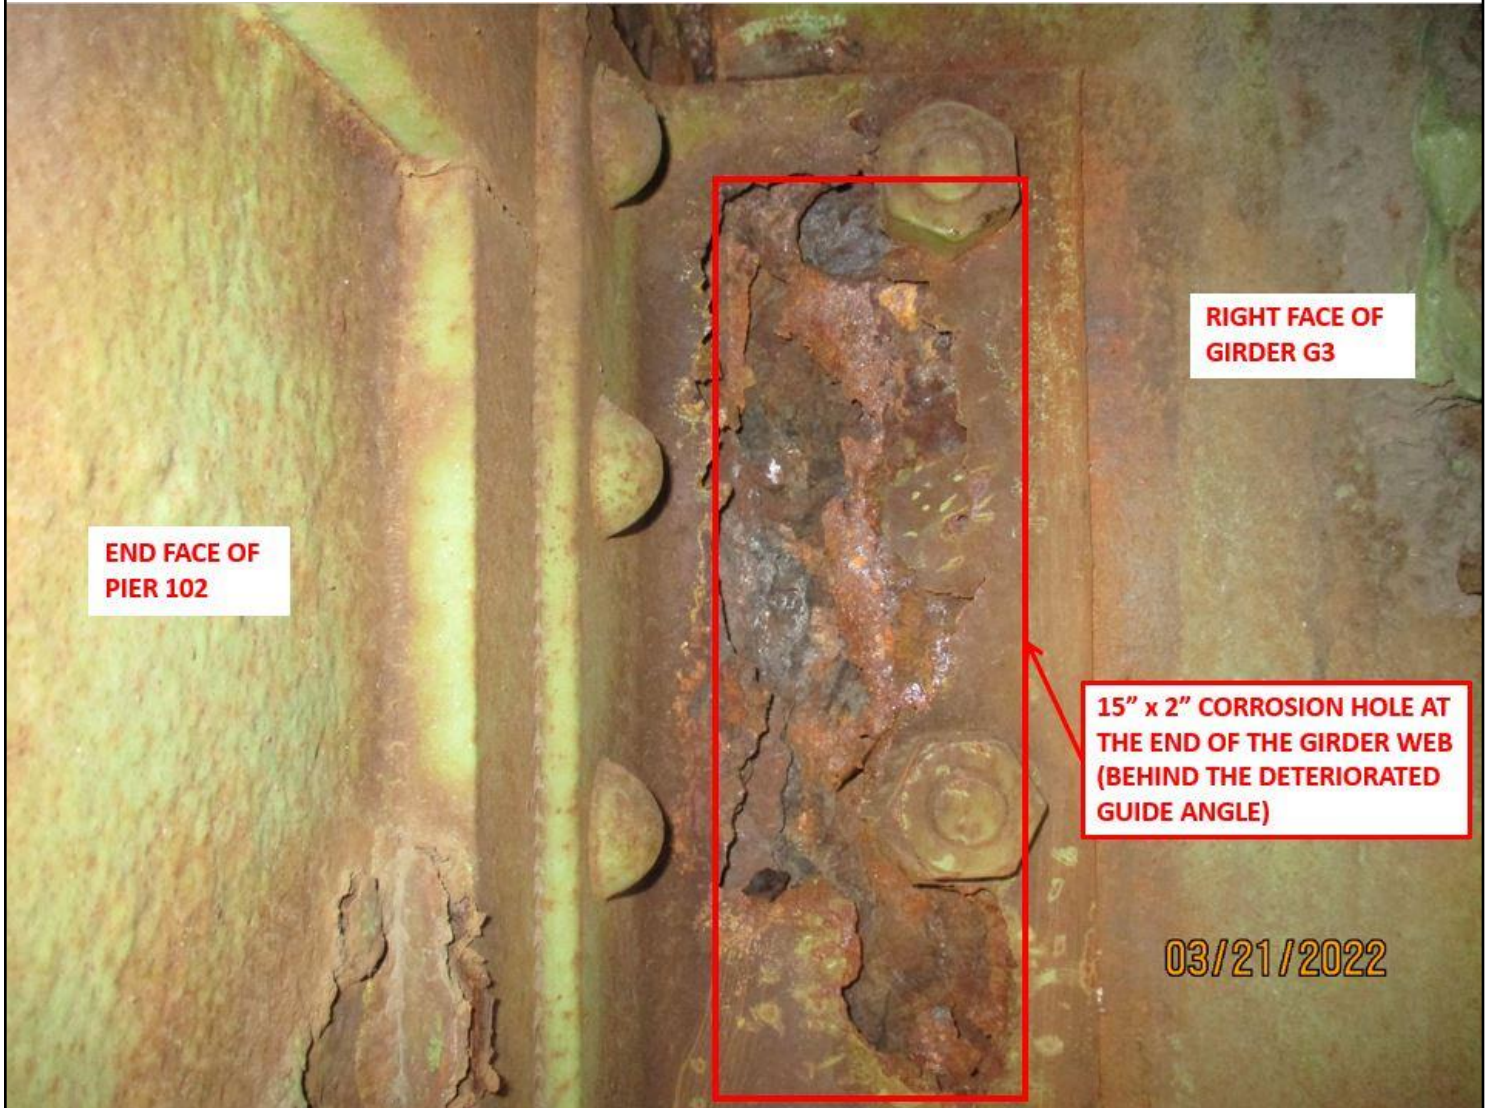
Photo Number: 3

Attachment Description: The right face of Girder G3 in Span 103 at Pier 102. The end of the girder web exhibits a 15" x 2" corrosion hole with section loss adjacent to the web hole, behind the deteriorated guide angle. Looking Left.

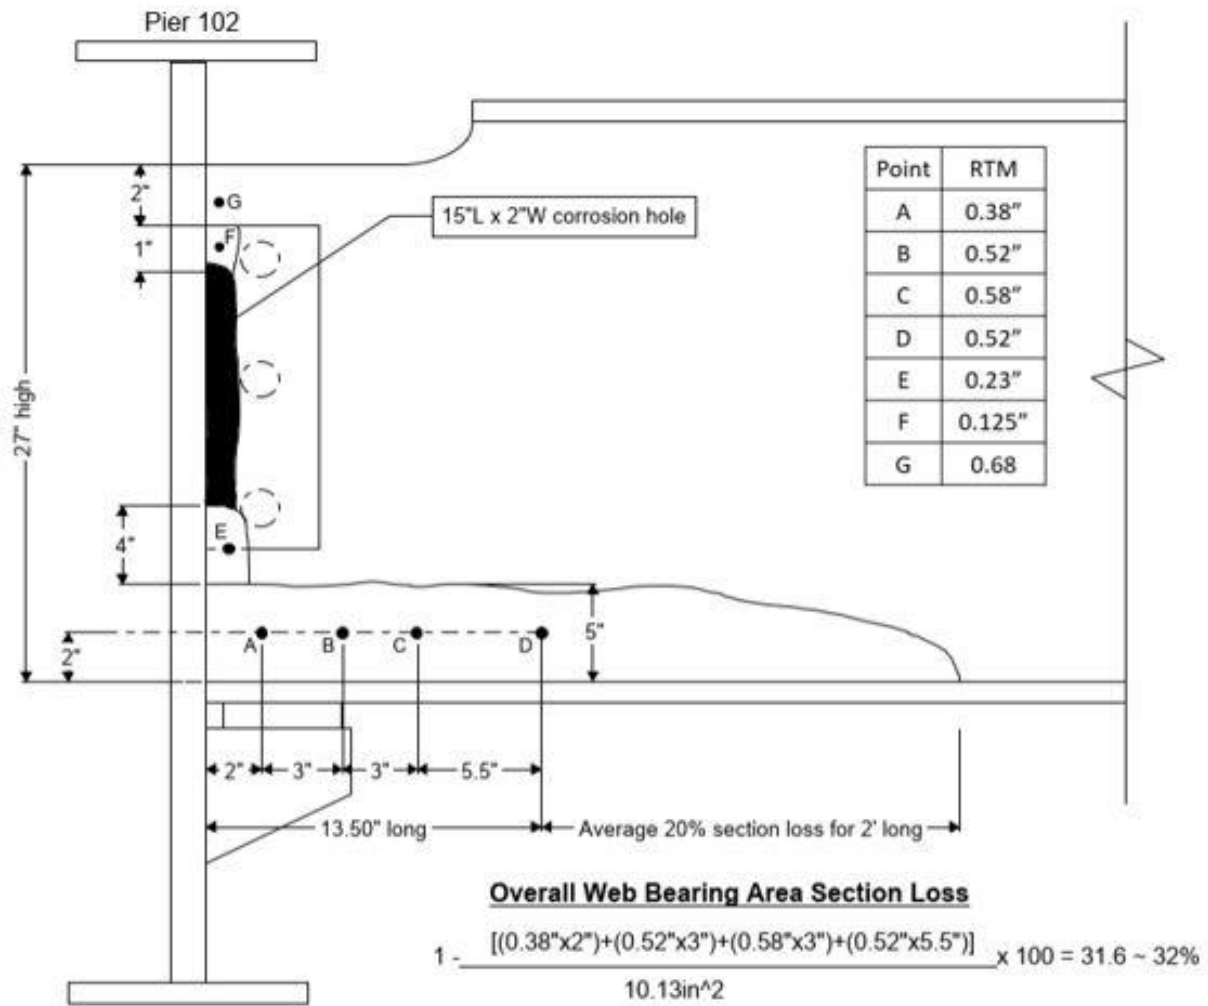
Right Face of Girder G3 Sketch in Span 103 at Pier 102

Description: The end of Girder G3 in Span 103 at Pier 102 exhibits severe corrosion resulting in an overall web bearing area section loss of approximately 32% (previously 30%) and an overall shear web area section loss of approximately 79% (previously 77%) with an average overall localized section loss of approximately 38% (previously 36%) for 5"L x 5"H area directly above the bearing below the guide angle (Photo 2). The end of the girder web, (behind the deteriorated guide angle), exhibits a 15"L x 2"W corrosion hole approximately 9" from the bottom flange (Photo 3). Also, the lower web of the girder adjacent to the web bearing area exhibits an average of 20% section loss for 2'L x 3"H above the bottom flange (Refer to sketch for more details). No significant change from previous inspection.

- As-built web thickness = 0.75"
- Length of bearing area = 18 x web thickness = 18 x 0.75" = 13.50"
- Overall bearing area = 13.50" x 0.75" = 10.13 in²
- As-built shearing web area = 27" x 0.75" = 20.25 in²
- Adjacent Girder G2 exhibits 20% section loss at the lower web above the bottom flange in front of the bearing with 1" diameter corrosion hole at the upper web adjacent to the top pre-drilled hole.
- Adjacent Girder G4 exhibits up to 30% section loss at the lower web above the bottom flange
- Right guide angle at Girder G3 exhibits 12" L x 4" W corrosion hole. This defect was not shown in the sketch for clarity purposes to display girder defects.

Attachment Description: Sketch of Girder G3 Section Loss
